Design Guidelines for Safety in Piping Networks

Karl Kolmetz
KLM Technology Group

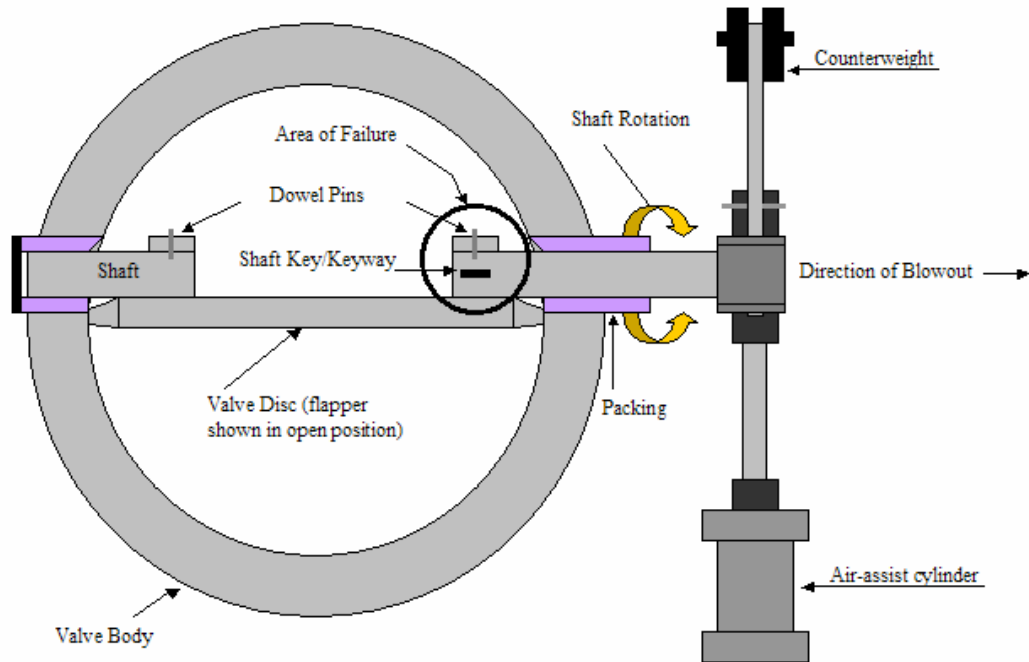
Simplified cross-sectional view of check valve (flow direction is into page)

During this period, the check valves installed in the propane refrigeration compression system slammed closed repeatedly. The shaft of the compressor's third stage discharge valve eventually separated from its disk and was partially ejected from the valve. The shaft was not fully ejected because its path was blocked by an adjacent steam line inches away from the valve, keeping about 70 mm of the shaft's length within the valve body.

A subsequent investigation and analysis of the check valve's internal components revealed that the dowel pin, which secured the drive shaft to the valve flapper, had sheared, and the shaft key had fallen out of its key-way. The investigation report also revealed that facility maintenance records indicated a long history of problems with the check valves installed there. The valves were installed in 1982, and due to continuing

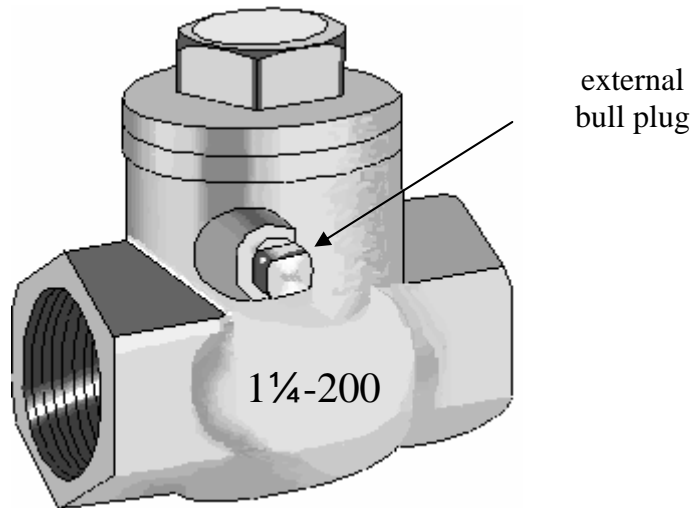
Case 3 - An Ethylene Plant in Louisiana had a near miss from a check valve failure in 1999. The check valve had an external bull plug, which allowed the check valve swing pin to be installed. The bull plug slowly rotated out over time leading to loss of hydrocarbon containment on a medium pressure ethane feed line. The line was isolated, copious amounts of water were applied to the leak, and fortunately the vapor did not find a source of ignition.

This check valve was far away from a source of vibration such as a compressor. The root cause of the incident is was not totally identified but one theory is that normal piping vibration caused the bull plug to rotate. The Ethylene plant reviewed all check valves in hydrocarbon service and installed a anti rotation locking device to prevent the bull plugs from rotating and causing a loss of hydrocarbon containment.

Review large and small check valve installations for potential release scenarios. For large high-pressure check valves review the internals and the sited case study failure mechanism. Install anti rotation devices on external bull plugs.

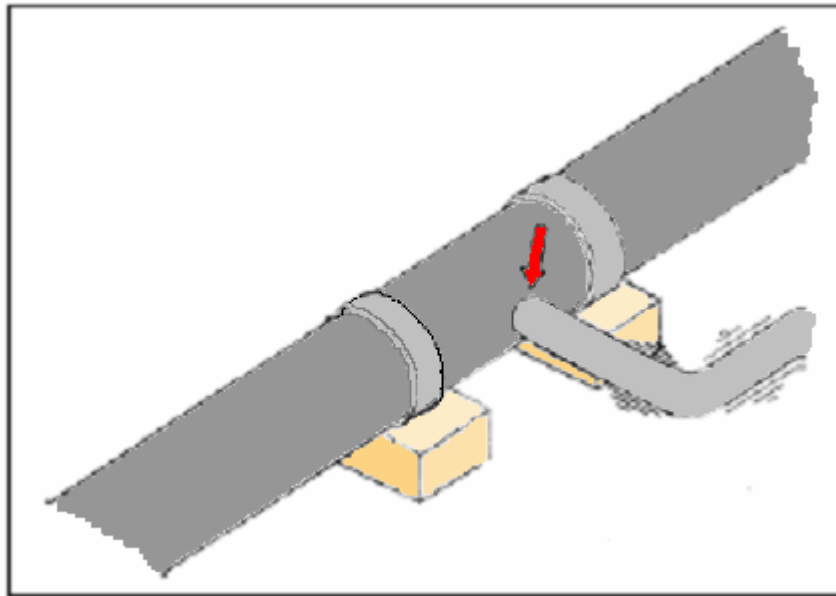
Since 1997, sixteen incidents attributed to vibration fatigue failure of piping within compressor stations and pump stations were reported to the Canadian National Energy Board (3). The fractures associated with these incidents typically initiated near welded junctions where small diameter pipe (NPS 2 or smaller) was tied into a larger pipe. The typical location where this occurred is on the discharge piping immediately downstream of a compressor/pump unit. The consequences of these failures include facilities shutdown, worker injuries, loss of product and site contamination.

Although vibration fatigue has been deemed to be the immediate cause of all these failures, poor design and lack of effective piping support is considered the basic cause of the incidents. Designs included poor support for the smaller pipe components, sizing (length, diameter and thickness) of the piping itself, and lack of consideration for additional stresses on the pipe-to-pipe junction in situations where a valve or regulator was installed at the remote end of the small diameter pipe. This resulted in bending stresses at the junction being increased to the point of failure.

Vibration levels imparted to the piping adjacent to compressor/pump units should be monitored and managed. Piping configurations potentially at risk such as the one described above should be investigated and modified to manage any vibration, which may impact the pipe and associated junctions.

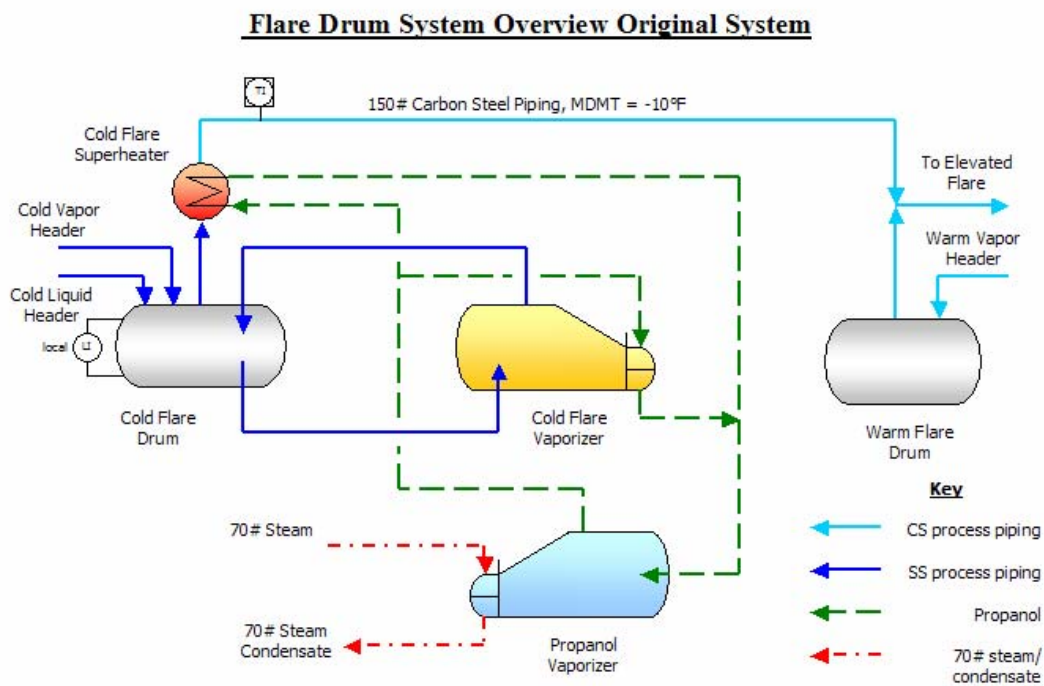
The cold flare drum contents are vaporized and superheated with a closed loop propanol system. Heat is supplied to the propanol system with 70-pound steam, which is about 270 F. The vaporizer and super heater heats the cold flare drum material from cryogenic temperatures to above the minimum design metal temperature of the cold flare drum carbon steel overhead piping.

The event sequence was the ethylene product went off specification on acetylene and initiating flaring of liquid ethylene product began. The acetylene converter outlet analyzer was in error, which allowed the ethylene splitter inventory to be contaminated with acetylene prior to corrective action being taken. A portion of the off spec liquid ethylene product was consumed by internal customers, with the balance being flared via the cold flare drum. Malfunction of the cold flare drum vaporizer and super heater allowed the cold flare drum overhead line temperature to fall sharply.

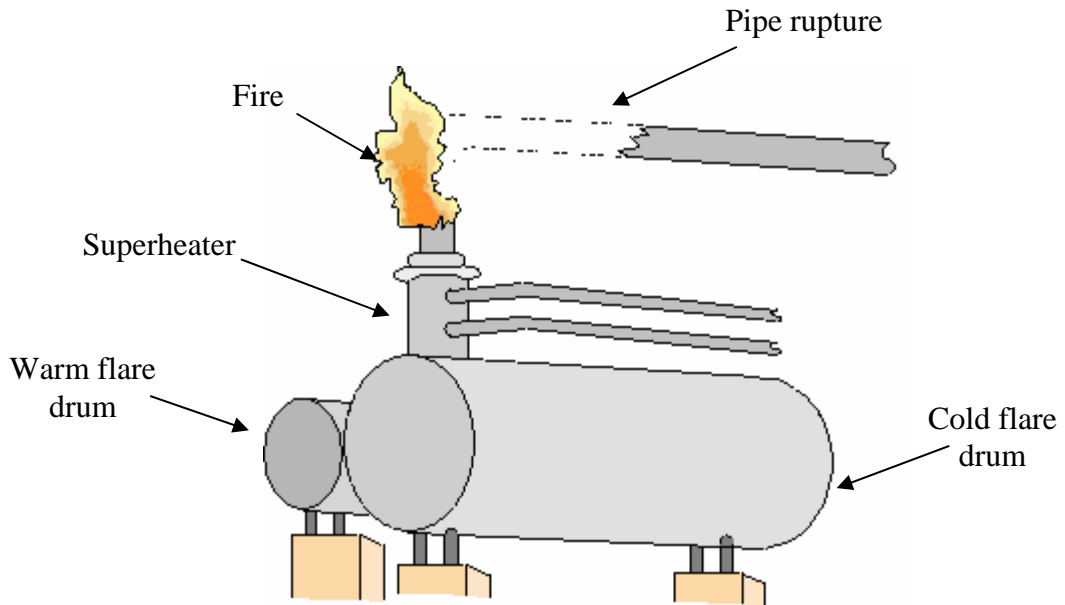
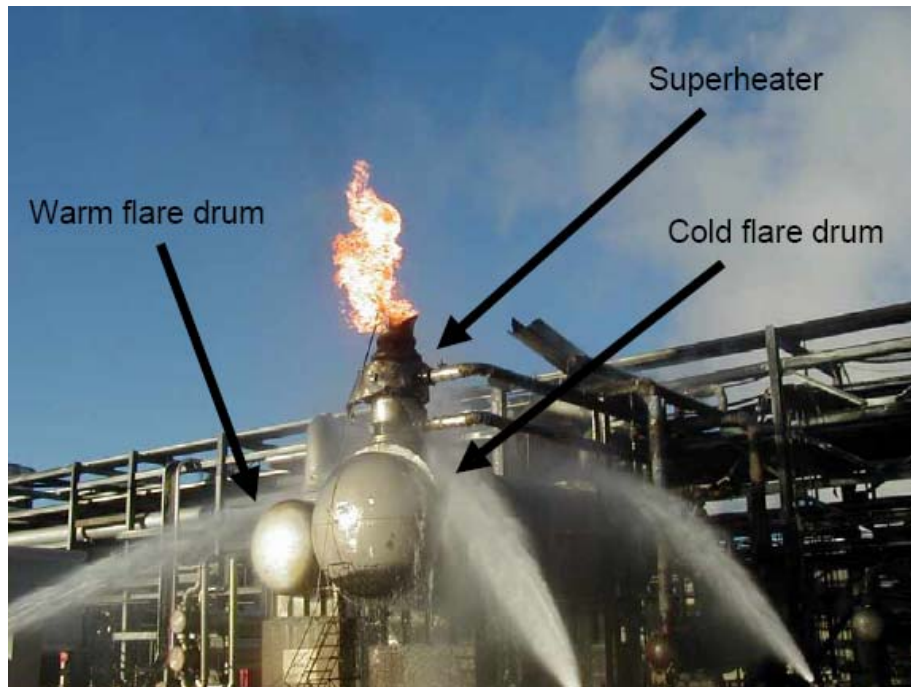
A low temperature alarm sounded as the overhead flare line temperature fell to 0 F, and the thermocouple went bad at a value of -13 F. With the cold flare drum overhead line running below its minimum design temperature of -10 F, the pipe ruptured, resulting in loss of hydrocarbon containment. The hydrocarbon released found an ignition source, resulting in an explosion and fire.

The root causes of the incident included the vaporizer and super heater exchanger fouling, which had reduced heat transfer capacity of the cold flare system. Once flaring began, the cold flare drum overhead line experienced low temperature resulting in the brittle fracture of cold flare drum overhead piping due to operation below the minimum design temperature of the carbon steel line.

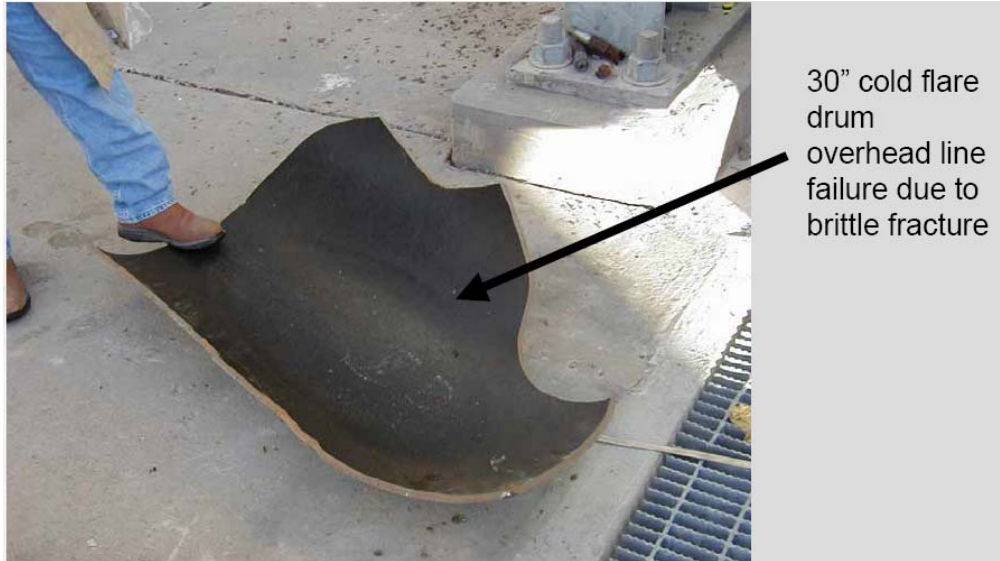
The final stress that ultimately caused the brittle fracture of the piping has not been identified, but could have been any number of internal or external stresses. 1) External stress - Hard rain that came at the time of event, 2) Internal stress - Contraction of the cold flare line due to temperature gradient.

The incident causes an explosion and damage to equipment, but no first aid or recordable incidents to personnel. As a result of the incident the ethylene plant upgraded many carbon steel systems to stainless steel, which has a lower temperature limit.
